# Coated Bolts Can Improve Constructability

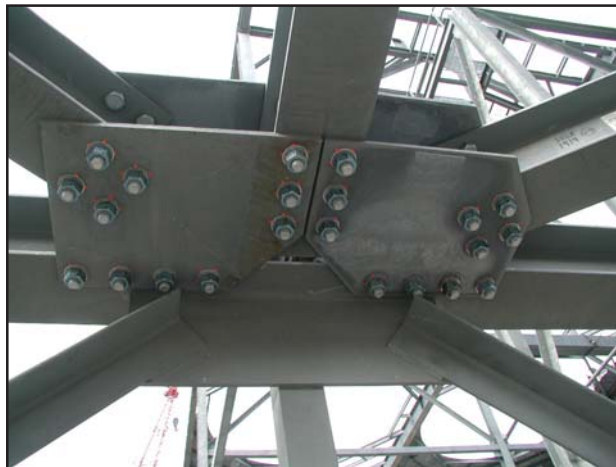
Figure 1: Squirter DTIs came out of construction concerns

An example of innovative thinking is the "Squirter" DTI that, yes, costs a little more, but enables faster and more efficient bolting installation and inspection. Squirters were originally developed in response to DTI users who complained about the labor involved in using feeler gages. The ease of visual inspection by looking at the appearance of the squirted silicone make feeler gages almost completely unnecessary. Since Squirter DTIs save about 20% of field bolting man-hours, which would cost more than the Squirters add, the constructability of the project is improved.

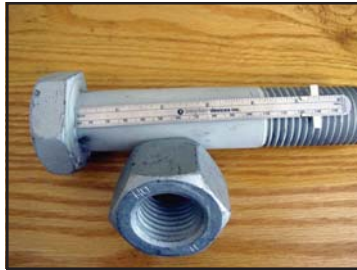
Figure2: Dacromet Coating Boeing Bolt

The Delta Heavy Lift EELV rocket is the second most powerful payload booster in the U.S., next to the space shuttle. Before launch it is held down by several large connection devices called “Frangible boxes,” each containing 16 dacromet coated 1-1/2” A490 bolts, and DTIs. As the rocket ignites, the boxes are explosively blown apart, allowing the rocket to disconnect from the launch pad. The bolts and DTIs are dacromet coated so they can be easily undone after sitting out in the salt atmosphere for a year on

the coast of Florida. The nice thing about dacromet is that no nut overtapping is required.

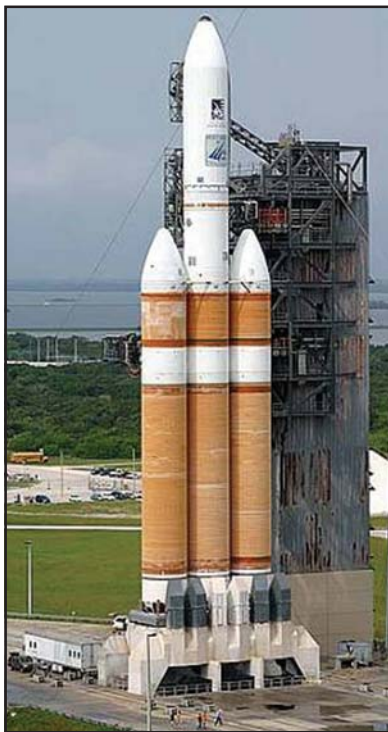
Figure 3: EELV Delta IV Rocket

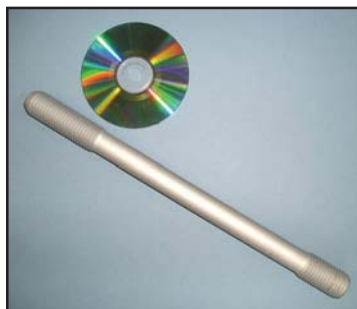
Figure 4: Delta Coated Stud

Delta, one of the “zinc/aluminum flake” thin-film coatings, combined with a lubricious top coat, has the ability to protect against corrosion, to smooth

out the highly variable torque resistance a bit, and make retightening possible even in marine environments after months and months in service. It also helps maintain a workable torque/tension relationship during the assembly of wind turbine generators.

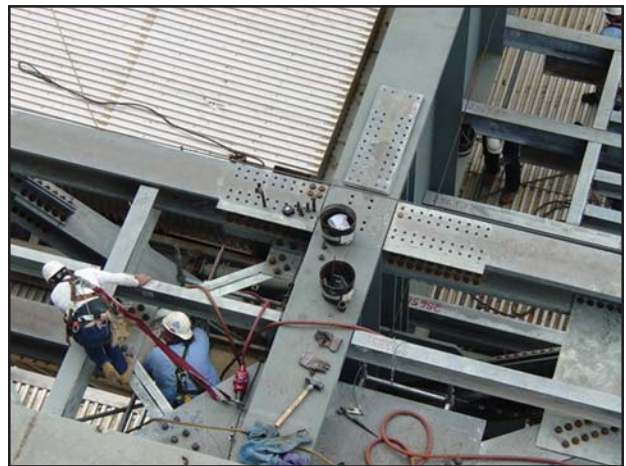
Figure 5: Power plants use hundreds of thousands 1-1/8” A490 Bolts

A490 bolts in power plants cannot be galvanized under the RCSC Specification, because of the potential for hydrogen embrittlement and subsequent fracture during service, and so they are most often used in the uncoated condition. And yet when installed in large complex frames, they must be left to weather for months, sometimes before final tightening. Not only is the final tightening made extremely difficult because of the rust on the bolts, field cleaning and painting is expensive. Applied Bolting recommended that the bolts be dacromet coated before shipping to site, making their installation much easier, and eliminating the necessity of field painting altogether. The cost of dacromet coating was US \$1.25 each, and the estimated savings in field labor was at least US \$5.00 each.

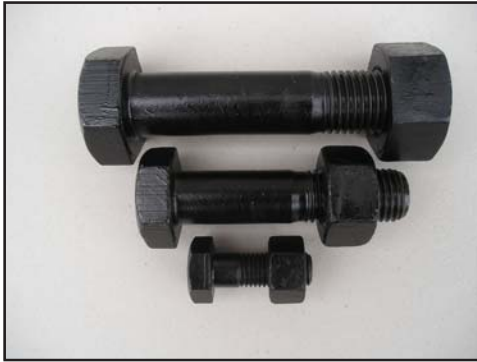
Figure 6: Iceland Xylan Coated Bolts

fluoropolymer applied over a cleaned and phosphate-coated substrate, such as used on studs in the off-shore platform piping business. The Xylan coating selected was applied to only 14 microns, but even with that thin a coating it was found necessary to overlap the nuts .2 mm for good fit.

The cost to apply Xylan turned out to be about 2/3rd of the hardware cost again, but even at that cost the overall savings by avoiding field painting was "substantial" according to the EPC contractor. And in an environment like the Iceland seacoast, the Xylan kept the bolts in very good condition as they were shipped,

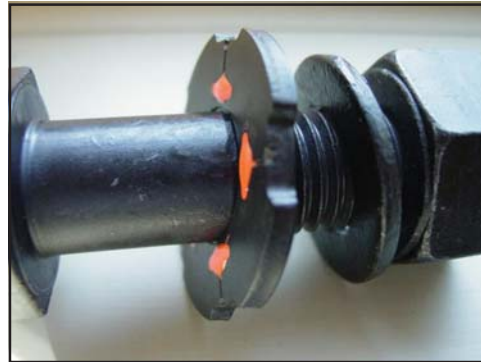
Figure 7: Iceland Fjardaal Project Xylan Coated Bolt/DTI

Ten-thousand tonnes of steelwork for smelter buildings more than a kilometer long, were fabricated and painted white in China. The steel was then shipped to a remote salt water fjord in NE Iceland, called Reydarfjörður, and was to be assembled with about 500,000 unpainted bolts (!) shipped from North America and England. The erected steel was intended to be field cleaned and painted. Constructability concerns highlighted the problems of labor availability and the inclement Icelandic weather which would make it very difficult to do this field painting properly. Zinc coated bolts were not thought compatible with the free HF ions in the aluminum mill atmosphere.
