Retightening Wind Turbine Flange Splice Bolts Inherent Problems With Installation and Retightening Using Torque Values

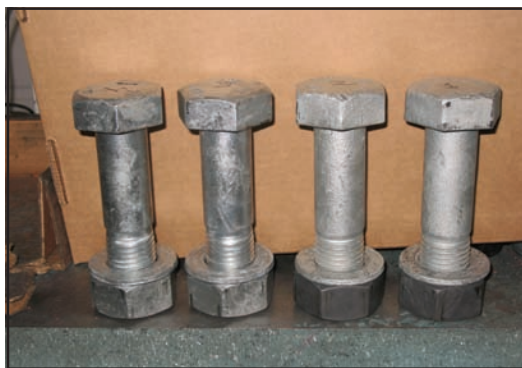
Four Bolts Tested

As a simple experiment, Applied Bolting tested two M36 x 140 galvanized 10.9 bolt assemblies, from two manufacturers, intended to be installed to 572 kN using a torque value of 3300 Nm. In experiment one, each of the two different manufacturer's bolt assemblies was tightened to 3300

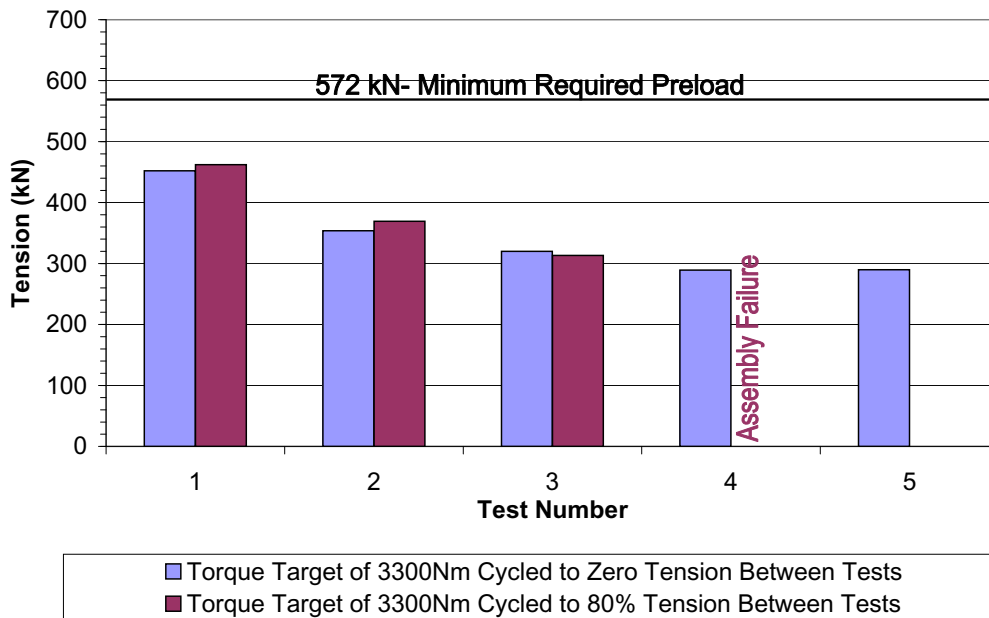
Bolt Maker 1

Retightening Tests

Nm, then unloaded to zero, and then retightened to 3300 Nm again, repeated five times. In experiment two, each of the two different manufacturer's bolt assemblies was tightened to 3300 Nm, then unloaded to only 80% of the tension achieved, and then retightened to 3300 Nm again. This cycle was repeated five times. The attached charts show the results of the (admittedly small) sample tests.

Both sets of bolt assemblies were tested in the as-received condition. You can see immediately that neither of the manufacturer's assemblies reached the mini-

As the charts clearly show, the second and subsequent tightenings, either unloaded to zero between

tightenings or only slightly unloaded to 80% of the previously achieved tension, certainly demonstrated the “sharp decrease” in induced tension referred to in the above research. In fact, the decrease in bolt capacity in only a few cycles was alarming, especially when retightening is intended to bring the bolt tension up to the original minimum value and therefore improve or restore the capacity of the joint.
