Lessons From the Field: If Your Squirter™ DTI Doesn't Squirt, You Have a Problem!

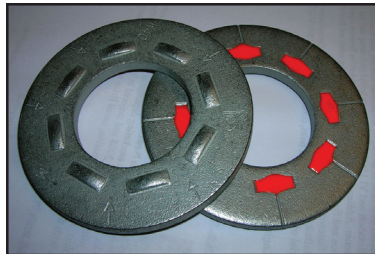
Figure 1: Typical Squirter™ and its Squirt Appearance at Load

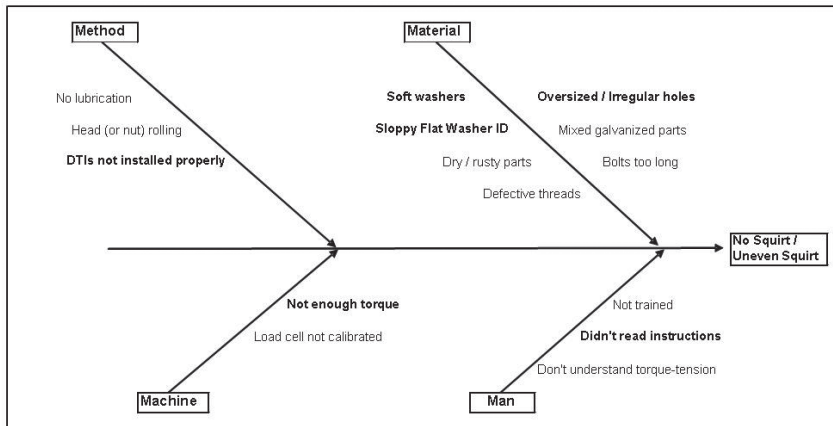
Figure 2: Cause and Effect Diagram for "No Squirt/Uneven Squirt"

The four M's relate to an approach to problem solving developed by Japanese scientist Karuo Ishikawa. He advocated a structured approach to cause and effect analysis. The Ishikawa diagram, also known as the Fishbone diagram, is a great structured problem solving tool. The diagram, shown in figure 2, resembles a fish. The head of the fish is the problem statement, and the bones are the four main root cause categories: Man, Machine, Material, and Method. While other categories can be added in unique situations, experienced users of this technique will testify that most root causes will fall into one of the "4 M's." A popular fifth "M" is Mother Nature, to be considered when natural elements cause problems. This particular diagram identifies potential root causes of the "no squirt/uneven squirt" problem.

Soft flat washers aren't the only thing that can go wrong in structural connections. The fishbone diagram in figure 2 lists the usual root causes we identify when a good squirt doesn't appear. The most frequent root causes are listed in bold text.
